## Metallographic and Mechanical Studies of a Cast Heat-Resisting Alloy

M. Aichaoui and A. Hadji

A heat-resistant steel tube from an ammonia plant made of modified HP40 steel that failed after short-term service is studied for damage mechanism. The assessment of material degradation is carried out using optical microscopy, scanning electron microscopy in combination with energy dispersive spectroscopy analysis, x-ray diffraction analysis, and mechanical tests. Results show that precipitation of the chromium-rich carbides induces the coalescence of grain boundaries. Significant growth and poor distribution of secondary carbides are also noticed through the matrix, which lead to a reduction of material ductility even after a short-term service. The main cause of failure appears to be damaged catalyst. Such a problem can cause a rise in temperature leading to localized overheating in the lower part of the tube. Overheating is primarily responsible for significant degradation in microstructure, creep strength, and mechanical properties of the tube.

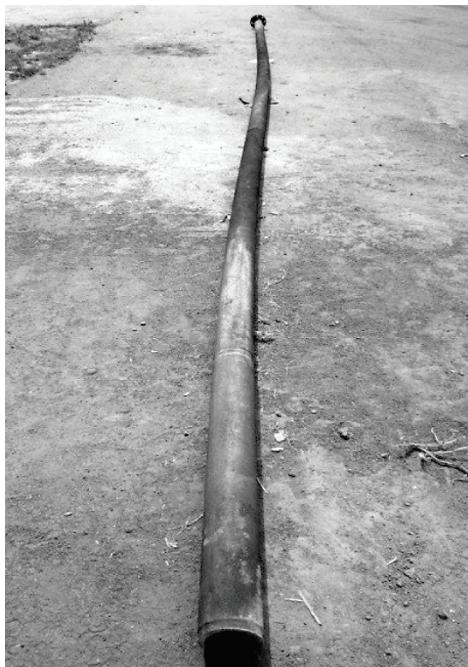
Figure 1 shows the damaged tube removed from the reformer furnace causing a shutdown of the furnace. Service exposed tube revealed normal appearance on both the inner and outer surfaces. There is no trace of cracks, carbon deposition or oxidation at a visual inspection. Even though localized plastic deformation were seen in the lower part of the tube. The content of the company report after failure shows that broken pieces of catalyst were seen. Such a damaged catalyst can cause a

**Fig. 1.** Photography of the failed tube.

rise in pressure and temperature by way of blocking the passage of the gas through the tube. Improper loading of the tubes with catalyst and extra shutdowns' cycles lead to the ineffectiveness of the catalyst.

The main cause of failure appears to be damaged catalyst. Such a problem could cause a rise in temperature leading to localized overheating in the lower part of the tube. This overheating lead to significant degradation in microstructure, creep strength and mechanical properties limiting the serviceability of the tube. Precautions should be taken while charging the catalyst to avoid such problems and to ensure the safe operation of the tubes.

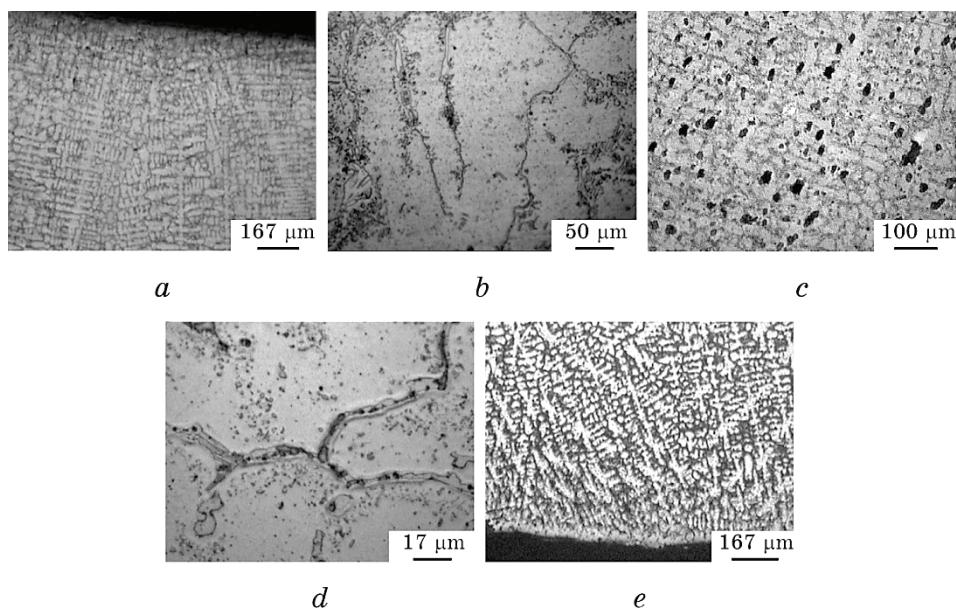
Microstructural examinations taken transversely to the tube axis focused on three regions, namely inner surface, midsection and outer surface. Figures 2, *a*, *b* show the optical microstructure performed on the inner surface. It can be seen the interdendritic network of primary carbides, coarsened and forming a continuous network. Secondary carbides precipitate at the intradendritic regions during service exposure. Carbides particles are not uniformly distributed through the structure this can strongly affect the mechanical properties of the alloy. Creep voids in isolated form were seen in the inner wall. The creep voids are formed by the generation of missing atoms produced during diffusion of species under stress forming at last pores [12]. In the midsection of the tube (Fig. 2, *c*), the ageing due to high temperature service induced the formation of many isolated microvoids with a largest peanut shape formed by the coalescence of two or more voids leading to the progress of creep during service [13]. Figure 2, *d* shows the presence of string of cavities along the grain boundary, which link with increasing strain to

**Fig. 2.** Optical micrographs of transverse section of service exposed samples: inner wall (*a*, *b*), middle cross section (*c*, *d*), outer wall (*e*).

form microcracks. No creep voids were visible on the outer surface of the tube (Fig. 2, *e*).

The combination of thermal stresses and internal pressure stresses causes creep damage that typically develops at the inner surface of the tube and just below the inner surface. This is the reason as to why creep voids were absent from the outer surface. However, decarburization layers followed by internal oxidation were observed both in the outer and inner surfaces (Figs. 2, *e* and 3, *a*). In the preservice condition, for the cast HP-microalloyed grade, microstructure is characterized by an austenitic matrix and a network of primary carbides [14].

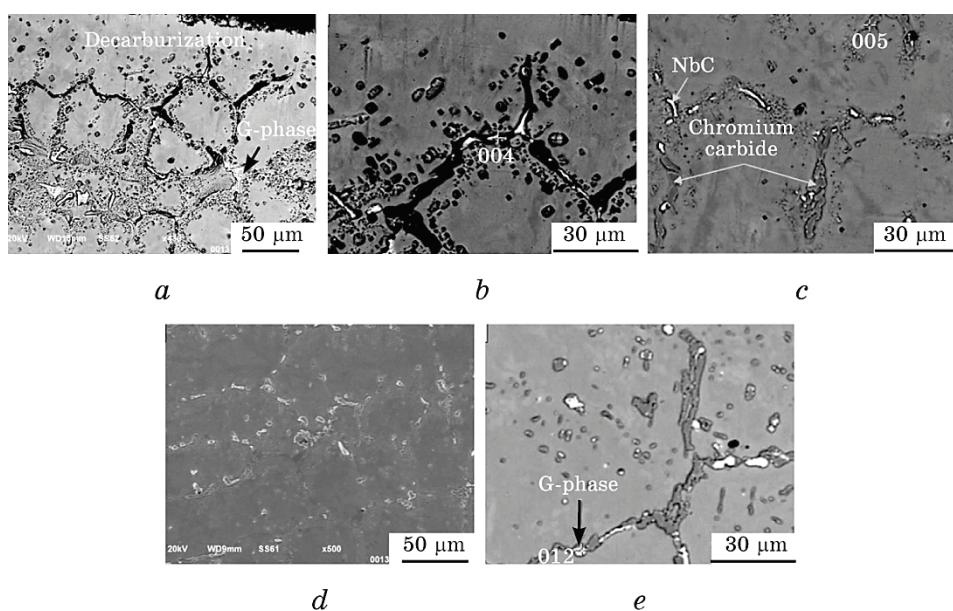
**Fig. 3.** SEM BSE and SEI micrographs of service exposed simples: inner wall (*a*), higher magnification of Fig. *a* (*b*), middle cross section with more blocky precipitation (*c*, *d*), outer wall evidencing the G-phase (*e*).

Nevertheless, continuous form of carbides will not be able to block dislocations motion and grain boundary sliding. In this case, plastic deformation of the tube occurs easier, creep will especially manifest in the lower part of the tube under the effect of its weight. Carbides in Figs. 3, c, d are noticeably coalesced and blocky, which indicates overheating. Generally, precipitation and growth of carbides occurs for

However, this process needs a long time at normal service temperature. In the present study, it took only one year. This confirms that the failure is mainly due to localized creep deformation under overheating conditions. In Figure 3, light grey precipitates are observed and marked with arrows both at inner (Fig. 3, *a*) and at outer wall (Fig. 3, *e*). These precipitates are rich in Ni, Nb and Si as shown by the EDS spectrum in Fig. 4, *c*. As quoted in literature [19, 20], Nb carbides are not stable at temperatures between 700 and 1000°C, being transformed into nickel niobium silicides, identified as the G-phase. According to the results of the full area x-ray diffractions, there are four reflections on the diffraction pattern, which correspond to the G-phase.

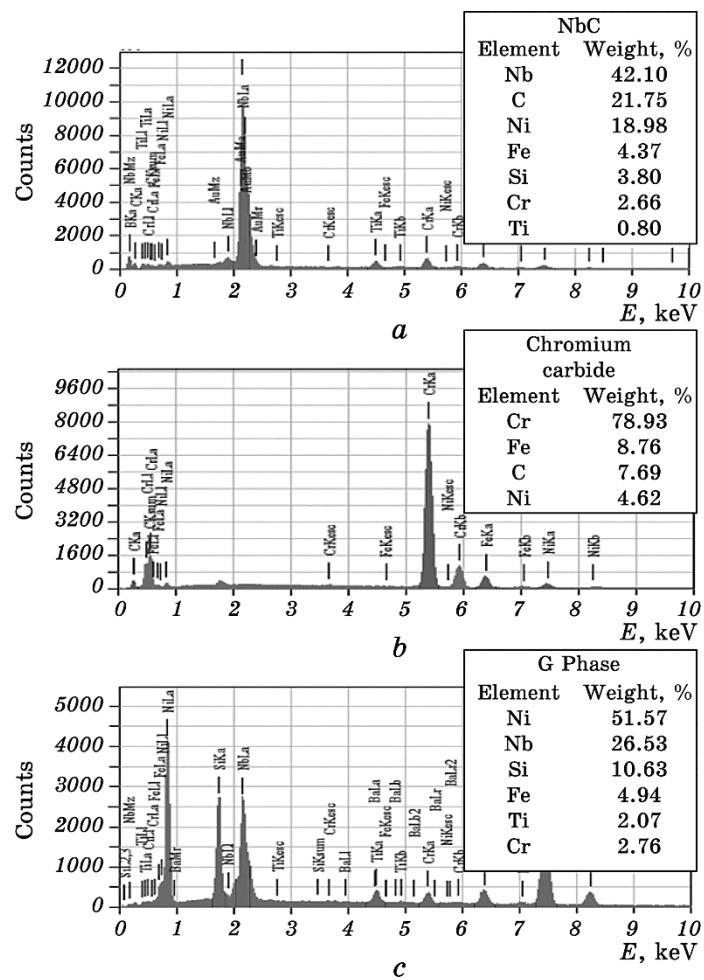
**Fig. 4.** SEM-EDS results of the precipitate phases marked with arrows in Figs. 3, a and b.

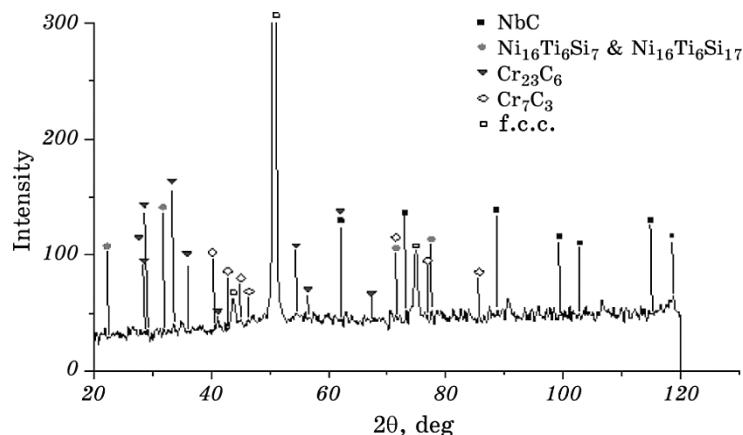
**Fig. 5.** XRD pattern of precipitate.

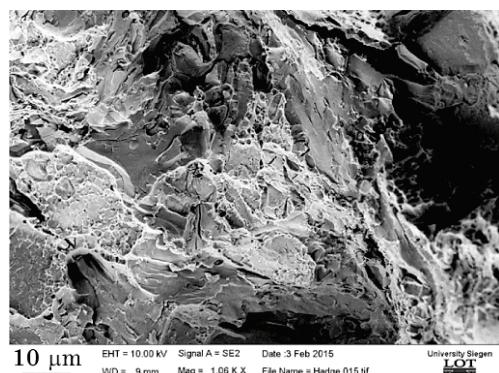
**Fig. 6.** Fractured surface.

The image of the fractured surface reveals a mixed mode of fracture. Most of the surface is of the fragile type with a shiny fracture surface. Changes in the microstructure such as coalescence of carbides and presence of voids reduce the energy absorbed during fracture. Little plastic deformation is observed due to the formation of some dimples. Since matrix, metal around precipitates has good ductility.

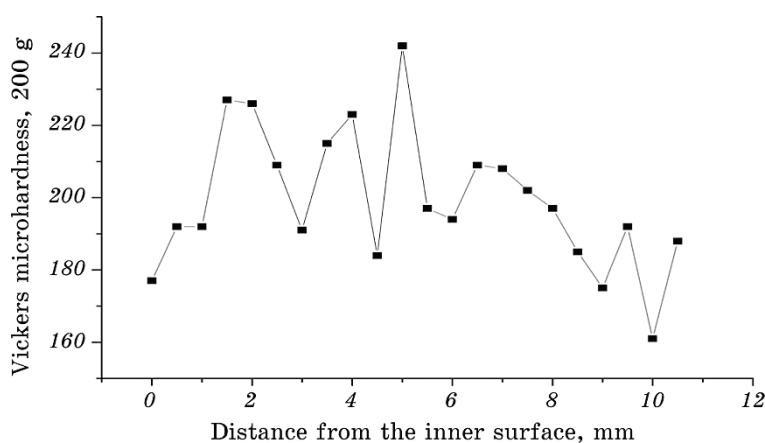
**Fig. 7.** Vickers microhardness profile measured across the wall thickness.

The measured results of the microhardness profile are shown in Fig. 7. It can be seen that the evolution of microhardness values is heterogeneously following the heterogeneity of the microstructure (carbides hard and less hard matrix).

A slight reduction in the microhardness in the external face compared to the internal is found. This is due to the size difference of the grains between the two surfaces caused by the cooling rate during solidification process.
