## INFLUENCE OF TiN-INCLUSIONS AND VIBRATION LOADS FOR DAMAGE TO HEAT EXCHANGE PIPES OF STEAM GENERATORS PGV-1000

*A.S. Mitrofanov*

*National Science Center “Kharkov Institute of Physics and Technology”, Kharkiv, Ukraine  
E-mail: mitrofanov@kipt.kharkov.ua*

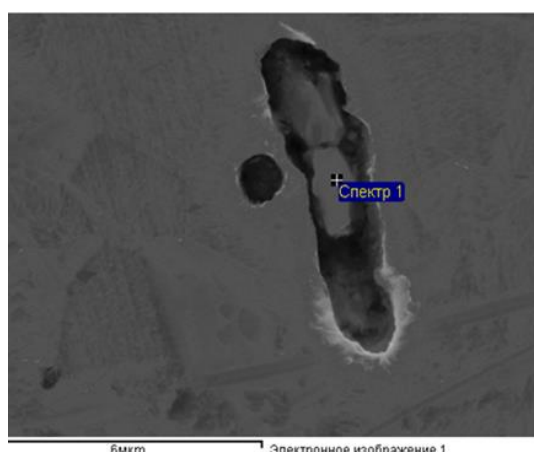
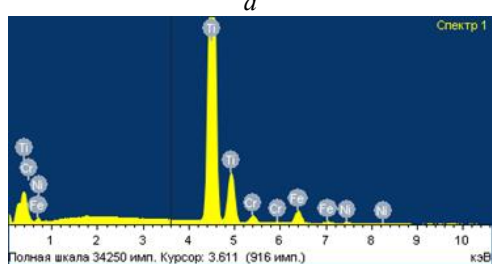
In high-quality steel 08Cr18N10T, which is used for the manufacture of HET, non-metallic inclusions of nitrides, sulfides and carbonitrides are allowed at the level of the fourth point according to the standards [5]. The presence of titanium nitride inclusions in steels alloyed with titanium was also found in [6], where the non-metallic phase in austenitic stainless steels 08Cr18N10T and 03Cr18N10T was studied by scanning electron microscopy. When studying the HET material, in addition inclusions of titanium nitrides, inclusions of metallic titanium (Fig. 1) and globular titanium sulfides (Fig. 2) were found in it.

Fig. 1. Microsection in the cross section of HET with the inclusion of titanium in steel 08Cr18N10T (a), EMF spectrum (b) and elemental composition of the inclusion (c)

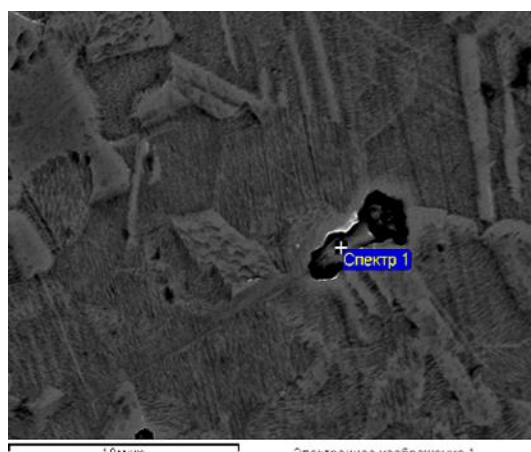
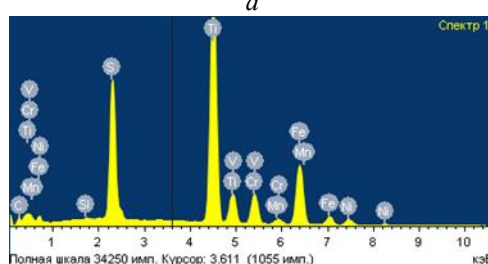
Fig. 2. Thin section in cross section HET. Inclusions of titanium in steel 08Cr18N10T (a), EMF spectrum (b) and elemental composition of the inclusion (c)

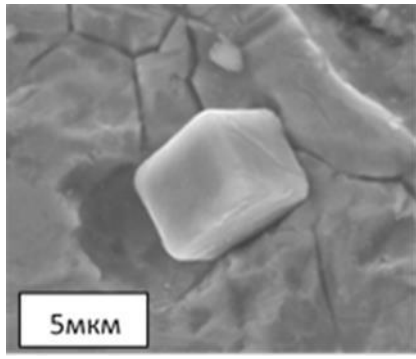
Figs. 3 and 4 show TiN inclusions found on the HET surface. The inclusion in Fig. 3 was pressed by a rolling roller into the metal surface without dragging.

Fig. 3. Inclusion of TiN on the HET surface

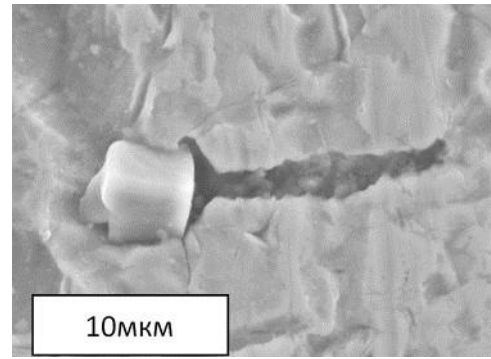
In the manufacture of pipes using the cold rolling method, TiN inclusions leave grooves on the metal surface. Fig. 4 shows the surface of the metal with a trace from the dragging of the inclusion before it was pressed into the metal and partially collapsed. It can be assumed that inclusions and grooves from them are the centers of crack initiation during the operation of HET.

Fig. 4. Inclusion and trace from its dragging

The mechanism of formation of cracks in the walls of HET on the traces of drawing of inclusions left during cold rolling, considered in the work, gives grounds for recommendations to produce pipes up to the size of HET by hot rolling. Solid TiN inclusions during hot rolling are pressed into the matrix without drawing along the surface. Inclusions do not leave scratches and do not act as stress concentrators. The degree of cleanliness of the pipe surface during hot rolling decreases, however, in our opinion, this will not have a significant effect on the performance of the HET. Concerning the issue of the influence of inclusions on the resource characteristics of HET, it should be noted that the HTC methods show a large number of cracks in them that have stopped growing at the level of permissible defects. There are also through cracks that do not leak. This is quite understandable, based on the features of the crack formation mechanism discussed above, and suggests that the current kill criteria are do not quite correspond to the actual performance of the HET.

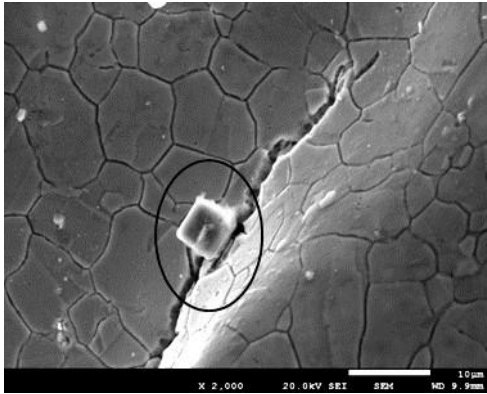
Fig. 5 shows the surface of the HET with the ends of the cracks. The surface is cleaned of oxide deposits and etched electrolytically. The ends of the cracks are located in the depths of the “troughs” formed as a result of the washing out of the oxidized metal in the vicinity of the crack. The cubic Ti crystal is located directly above the crack channel (Fig. 5,a).

Fig. 5. Crack endings on the HET surface: TiN above the crack channel (a), transcrystalline nature of crack growth (b)

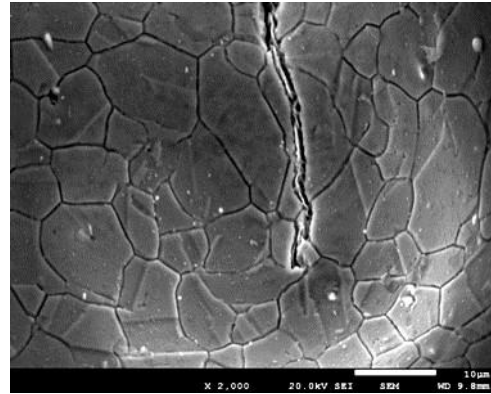
b

The matrix material (steel 08Cr18N10T) has an austenitic structure with a grain size of 5...10 μm. The crack propagated through the grains in a transcrystalline manner (see Fig. 5,b).

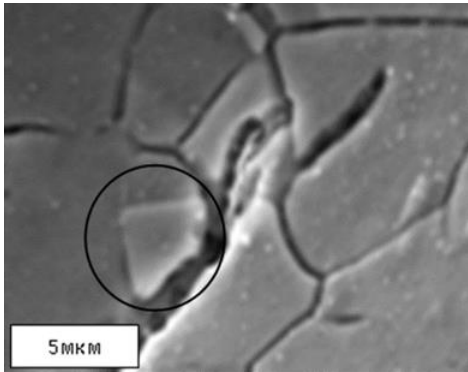
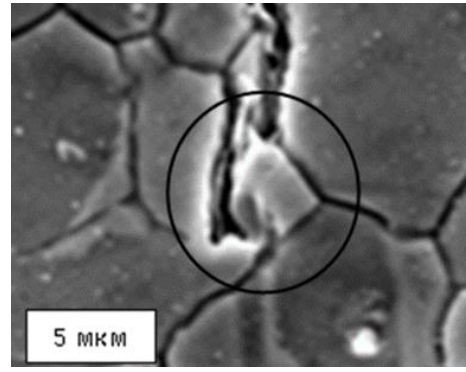
The ends of other cracks are shown at higher magnification (Fig. 6). As can see, cracks break off rectangular fragments from austenite grains, and these fragments are TiN inclusions.

Fig.6. Crack ends (a) and inclusion on the HET surface (b)

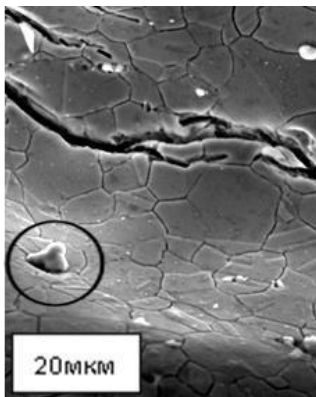
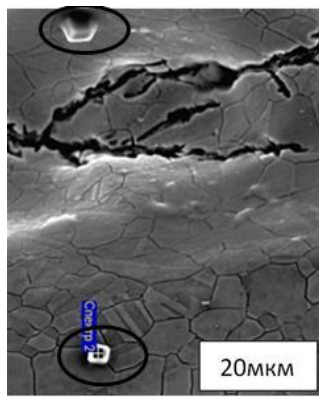
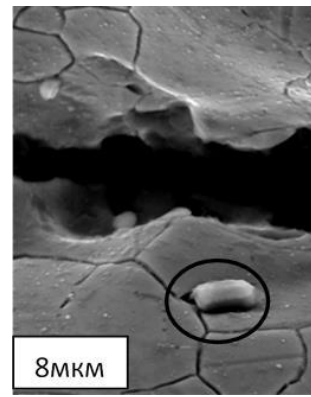
Cracks in the middle part are shown in Fig. 7. Smooth bends and branchings characteristic of transcrystalline cracks are observed (see Fig. 7,a,b). Cracks opening in their middle part it can be quite large (see Fig. 7,c), while the outlines of the coasts do not correspond to one another. TiN inclusions partially embedded in the metal are observed on the banks of cracks (highlighted by contours). This confirms the participation of inclusions in cracking.

Fig. 7. Middle part of cracks and inclusions of titanium nitrides on the HET surface (a,b,c)

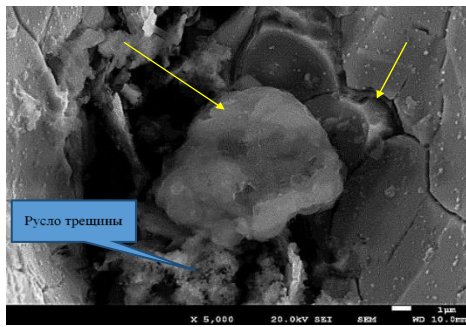
Fig. 8 shows a fracture in the middle of a crack on the tube surface. It can be seen that the crack bed is filled with corrosion products.

Under the layer of oxides, the outlines of a cubic inclusion are guessed, similar to the inclusions of titanium nitrides shown earlier.

Fig. 8. Fracture on the surface of the tube. The arrows indicate the oxidized grain of the matrix metal and the cubic inclusion

The shapeless fragment in the center (shown by the arrow) is an oxidized grain of the matrix metal that has

broken off from the crack wall, which most likely contains an inclusion of titanium nitride. It can also be seen that around the inclusion, along the grain boundaries, the edges of the crack collapsed, obviously, when it collapsed under the action of vibrations.

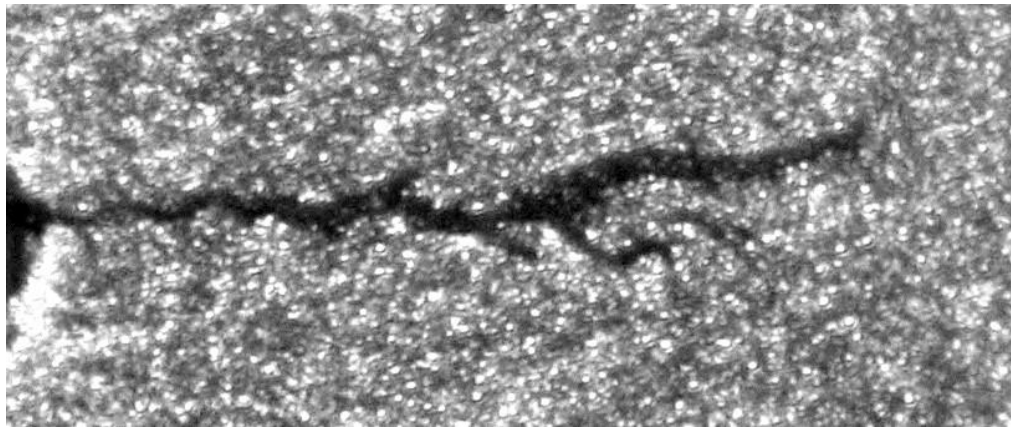
**Cracks in the walls of the HET.** Cracks in the walls of the HET were studied on thin sections in the cross section of the tubes. Cracks propagate into the metal perpendicular to the outer surfaces of the tubes. Secondary cracks branch off from the main crack. In this case, the general direction of cracking is preserved (Figs. 9, 10). The channels of cracks are widened due to deposits of corrosion products in them. One can see TiN inclusions near the crack tip (Fig. 10,b).

Fig. 9. Typical crack in the HET wall

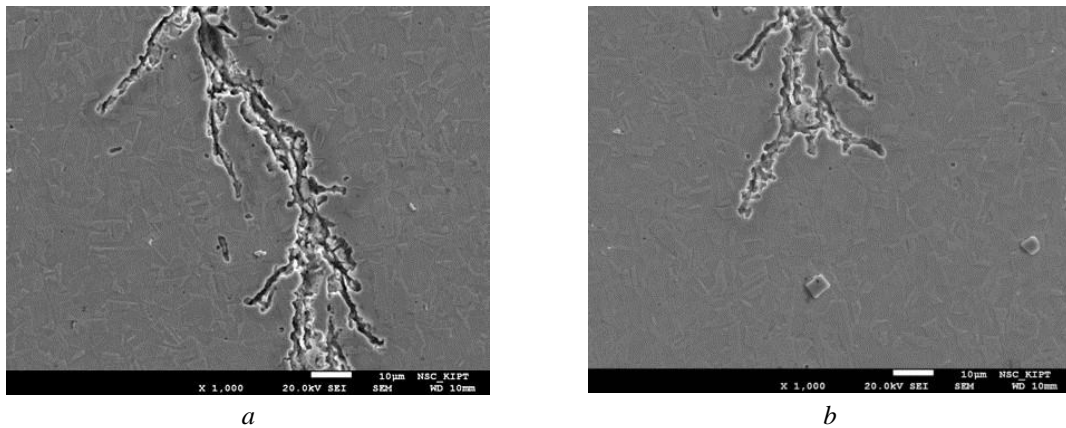
Fig. 10. Cracks in HET walls: middle part (a), crack tip and inclusions (b)
