## Strength of Reactive Powder Concrete Beam-Column Joints Reinforced with High-Strength (HRB600) Bars under Seismic Loading

*In order to study the seismic behavior of reactive powder concrete beam-column joints reinforced with high-strength bars, an experimental investigation was carried out. A total of 5 reinforced reactive powder concrete exterior joint specimens (including 2 specimens with HRB600 steel bars and 3 specimens with HRB400 steel bars) were cast and tested. The seismic behavior of 5 existing test specimens was studied, including failure mode, hysteretic behavior, deformation capacity, ductility, energy dissipation capacity, and strength and stiffness degradation. The results showed that failure modes of reactive powder concrete beam-column joints under reversed cyclic loading are mainly flexural failure of the beam adjacent to the joint core, shear failure of the joint core, or combined failure of the plastic hinge in the beam and shear in the joint core. The configuration of HRB600 bars in reactive powder concrete beam-column joints alleviates the destruction, reduces the degradation of strength and stiffness, lessens residual deformation, and enhances both deforma

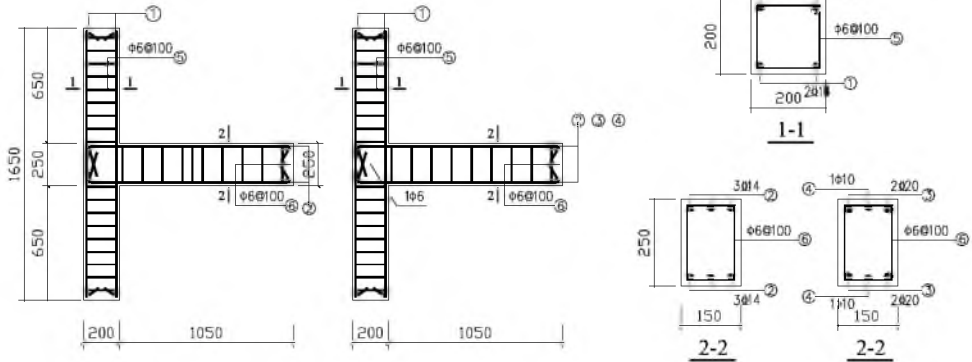
Fig. 1. Design details of specimens.

1.1. *Design Details of Specimens.* Five exterior beam-column joints of a reinforced concrete frame structure, isolated at the inflection points of both the beam and column, were designed and constructed. Specimens EJ-4EA-0, EJ-4EA-1, and EJ-4ES-0 were reinforced with conventional HRB400 bars, while the remaining two specimens, EJ-6E-0 and EJ-6E-1, were reinforced with high-strength HRB600 bars. In the specimen names, EJ represents the exterior joint. 4E and 6E represent the HRB400E and HRB600E strength grades of the longitudinal reinforcements in the beam, respectively. 4EA and 4ES represent longitudinal HRB400E reinforcements that, compared to the HRB600E reinforcements, had either the same area or the same strength, respectively. The numbers 0 and 1 represent the number of stirrups in the joint core. The strength grade of the longitudinal reinforcement in the column is the same as a beam; the stirrups of all specimens are rectangular D6 HPB300 reinforced bars. Mechanical properties of the reinforcing bars are shown in Table 1. Table 2 shows the parameters of the specimens. Figure 1 shows the design details of the specimens. The design value of the axial compression ratio is 0.3.

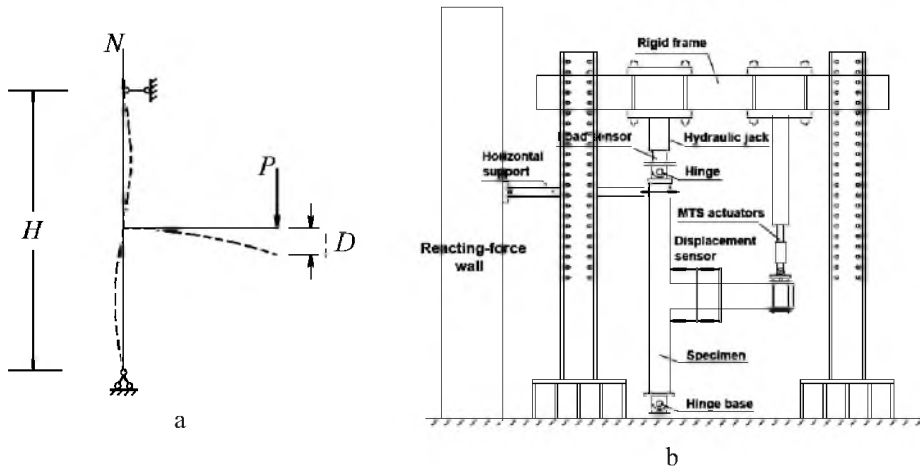
Fig. 2. Schematic diagram of the test setup: (a) loading scheme; (b) loading equipment.

1.2. **Test Setup and Loading Scheme.** Figure 2 is the schematic diagram of the test setup. The top of the column was subjected to constant loading ( $N$ ) during the test process. The beam tip was subjected to reverse cyclic loading ( $P$ ). Hinged supports were located at the bottom end and top of the column. The compressive load ( $N$ ) was applied on the column top by a 2000 kN hydraulic jack; the plunger of the jack was connected to the load cell to stabilize it.

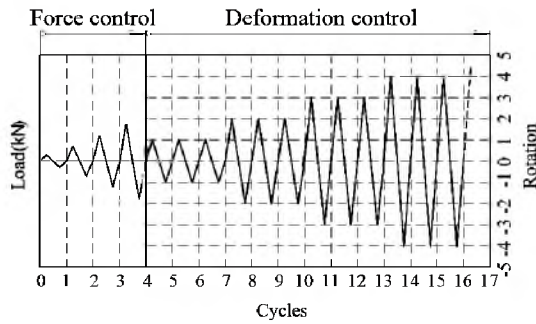
Fig. 3. The test loading process.

The reverse cyclic loading was applied to the beam tip using an MTS electro-hydraulic servo actuator. The load history of the beam tip was determined based on Chinese code JGJ101-96 [14], which includes a force control phase and a deformation control phase, as shown in Fig. 3. During the force control phase, the load increased by 5 kN each cycle. When shear cracks occurred in the joint core or when the longitudinal reinforcements in the beam yielded, the cyclic loading arrangement was switched to the deformation control phase. The deformation value is the defined yield deformation  $\Phi_y$  ( $\Phi_y = \delta/L$ , where  $\delta$  is the vertical displacement of the beam tip and  $L$  is the length of the beam). During the deformation control phase, the ends of the beam tip were subjected to load cycles at the levels of  $\Phi_y$ ,  $1.5\Phi_y$ ,  $2\Phi_y$ ,  $2.5\Phi_y$ , and so on. Three cycles were imposed at each deformation level. The test was continued until the load sustained had decreased to 85% of the maximum measured load strength.

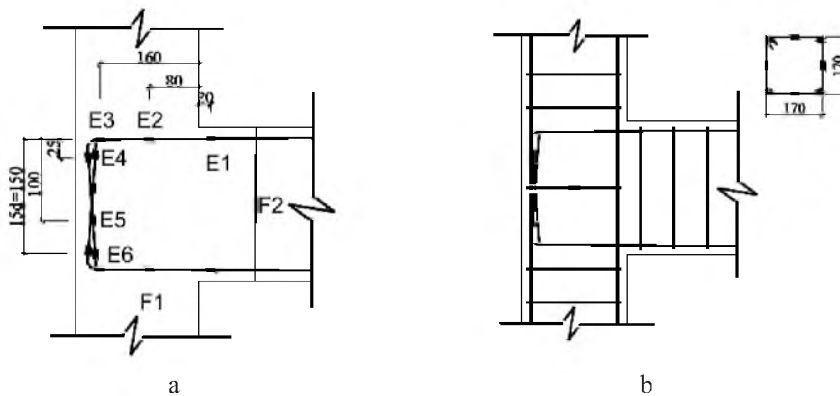
Fig. 4. Location of strain gauges on reinforced bar: (a) longitudinal bars in beam; (b) stirrups in joint core.

1.3. **Instrumentation.** The measured quantities included beam and column end force, beam end deformation, rotation angle, strains of the stirrup in the joint core and the longitudinal reinforcements in the beam, and the width of the crack in the joint core. The axial compression force at the column end was measured by a 2000 kN load sensor. The force and deformation at the beam end were measured by the load and displacement sensor in the MTS. The strains of the stirrup in the joint core and the longitudinal reinforcements in the beam were measured using electrical resistance strain gauges; the locations of the gauges are shown in Fig. 4. In order to measure average strain, two strain gauges were symmetrically attached to both sides of the longitudinal reinforced bars.

upward (negative) force, the first crack was observed on the bottom of the beam. Three new increasing cracks in the beam were observed at downward 30 kN force, with a maximum crack width of about 0.1 mm. Average strains at locations  $F1$  and  $F2$  (see Fig. 4a) quickly increased to  $1156 \cdot 10^{-6}$  and  $1061 \cdot 10^{-6}$ , respectively, at upward (negative) 35 kN force. In addition, four new cracks were observed in the beam, and the width of existing cracks increased. When the load increased to 40 kN, average strains at locations  $E1$  and  $E2$  further increased to  $1980 \cdot 10^{-6}$  and  $1193 \cdot 10^{-6}$ , respectively, and the maximum crack width increased to 0.14 mm. In subsequent loading, strains at location  $E1$  eventually reached  $3360 \cdot 10^{-6}$  at downward 55 kN force, and strains at location  $F1$  exceeded  $3400 \cdot 10^{-6}$  at upward 60 kN force, indicating that longitudinal reinforcements in the beam top and in the beam had all yielded. Initial cracks in the joint core formed along orthogonal diagonal directions. Cracks in the beam further widened during the early deformation control stage. When  $\Phi_y = 3.14\%$ , cracks in the beam developed faster and the maximum width increased to 2.4 mm. With the increase of loading deformation and load cycle, the widths of cracks in the beam end adjacent to the joint significantly increased, spalling of a small quantity of concrete occurred under compression due to crushing, and a plastic hinge formed in the beam adjacent to the joint core.

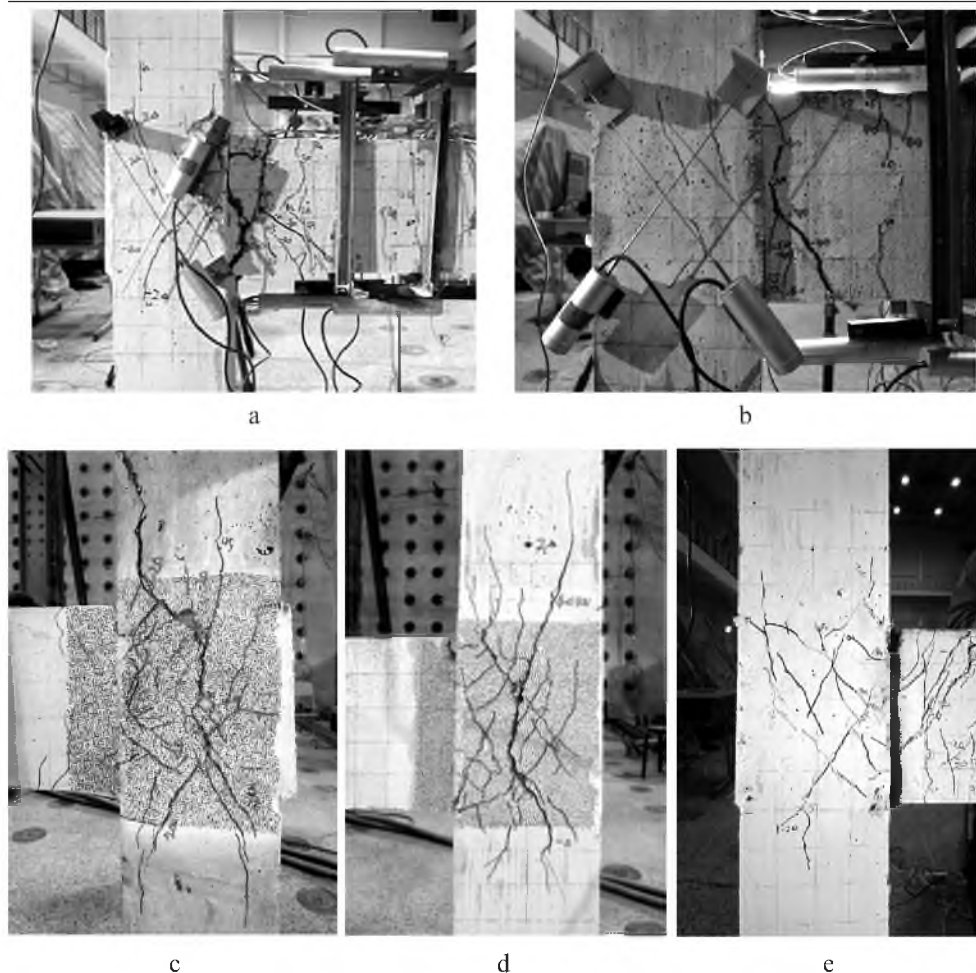
2.1. **Experimental Results.** Five types of specimens were tested as shown in Fig. 5.

Fig. 5. Failure mode of specimens: (a) EJ-4EA-0 flexural failure in beam; (b) EJ-4EA-1 flexural failure in beam; (c) EJ-4ES-1 shear failure in joint area; (d) EJ-6E-0 shear failure in joint area; (e) EJ-6E-1 shear failure in joint area.

2.1.1. *Specimen EJ-4EA-0.* At downward 19 kN force, the first flexural crack appeared in the beam at a distance of 125 mm from the column interface; the crack width was about 0.02 mm. At 25 kN upward force, two new cracks were observed on the bottom of the beam, with a maximum crack width of about 0.04 mm. New cracks appeared in the beam constantly with the increase of the load up to 40 kN; at that time, the average spacing between cracks was approximately 45 mm. Yielding of the beam's longitudinal bars was first observed in the top beam reinforcement at 40 kN downward (positive) force; the corresponding downward (positive) displacement was 17.2 mm. The longitudinal bars in the bottom beam reinforcement yielded when upward (negative) force was 45 kN, while the corresponding displacement was 16.4 mm. This marked the end of the force control stage.

During the  $\Phi_y$  deformation control stage, there was no obvious change in the existing cracks in the beam, and no new cracks occurred. At  $\Phi_y = 2.14\%$ , corresponding to the initial cracking strength of 51.2 kN, the first diagonal crack appeared in the joint core. The first diagonal crack was located in the center of the joint core and was parallel with the diagonal. Another crack formed along a different orthogonal diagonal direction at upward  $2\Phi_y$ . Some diagonal cracks appeared in the joint core in the second and third cycles of  $2\Phi_y$ . During the  $3\Phi_y$  stage, no new diagonal cracks appeared and there was less extension of the original diagonal cracks in the joint core, but the beam cracks became unstable. The crack widths increased quickly, accompanied by the spalling of a small quantity of concrete in the compression zone due to crushing. During the  $4\Phi_y$  stage, diagonal cracks in the joint core developed rapidly and eventually extended to diagonal corners, with a maximum measured crack width of 0.78 mm.

2.1.2. *Specimen EJ-4EA-1*. Similar to specimen EJ-4EA-0, the first downward (positive) 20 kN force caused a flexural crack in the beam at a distance of 150 mm from the column side. When the specimen was subjected to the downward 25 kN force, a second crack was observed in the beam at a distance of 140 mm from the column side. At 25 kN

2.1.3. *Specimen EJ-4ES-1*. The first downward 25 kN force caused a flexural crack in the beam at a distance of 100 mm from the column side. At upward 25 kN force, one crack was observed on the bottom beam. At downward 35 kN force, the first diagonal crack in the joint core occurred, along with the increase of flexural cracks in the beam. One diagonal crack along a different diagonal direction was observed in the joint core at upward 50 kN force. The loading method was then switched to deformation control. During the  $\Phi_y$  stage, no changes were observed in the existing cracks in the beam and joint. During the  $2\Phi_y$  stage, flexural cracks in the beam widened significantly, but diagonal cracks in the joint extended and widened only slightly. During the  $3\Phi_y$  stage, a number of small diagonal cracks occurred along the two orthogonal diagonal directions; the main diagonal cracks widened and propagated toward the upper and lower columns, followed by the spalling of concrete on the edges of the main cracks.

2.1.4. *Specimen EJ-6E-0*. The first flexural crack in the top of the beam was observed at downward 17 kN force, and the first flexural crack in the bottom of the beam was observed at upward 20 kN force. Two parallel diagonal fine cracks were observed in the center position of the joint core at downward 35 kN force. One diagonal crack along a different diagonal direction developed in the joint core at upward 48 kN force. During the  $\Phi_y$  stage, the cracks in the beam and joint core did not exhibit obvious changes. Some small diagonal cracks occurred in the joint core, while the main diagonal cracks extended toward the upper and lower column tips at the first cycle of  $2\Phi_y$ ; the maximum crack width reached 2.56 mm. With the further increase of load deformation, the number of cracks in the column and the diagonal crack width in the joint core markedly increased, while the steel fibers bridging across the main cracks were partially pulled out. Spalling of concrete occurred on the edges of the cracks due to crushing. Eventually, the specimen exhibited shear failure.

2.1.5. *Specimen EJ-6E-1*. Similar to specimen EJ-6E-0, the first flexural cracks in the top and bottom of the beam occurred at 20 kN force directed downward and upward, respectively. The first diagonal crack was observed at downward 43 kN force; the corresponding downward deformation was 2.2%. The first diagonal crack along a different diagonal direction in the joint core was seen at upward 45 kN force. The loading method was then switched to deformation control. During the deformation control stage, the strain of the longitudinal reinforcement exceeded  $2800 \cdot 10^{-6}$ , the yield strain of the steel bars. At this stage, an inconspicuous plastic hinge formed in the beam adjacent to the joint edge. As compared with specimen EJ-6E-0, specimen EJ-6E-1 had higher initial cracking strength and the failure cracks were less wide due to the configuration of the stirrup.

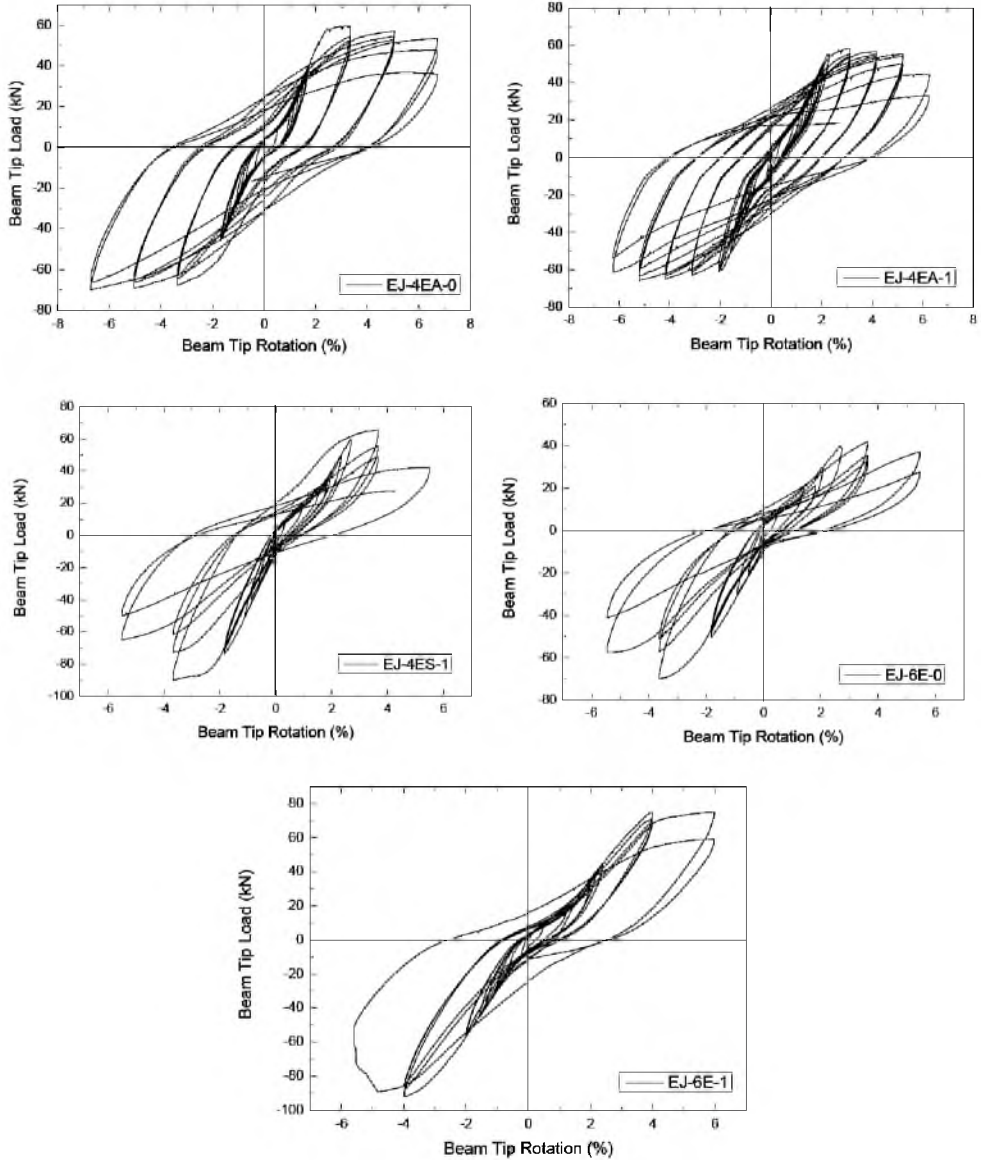
Fig. 6. Load-rotation hysteretic curves of specimens.

2.2. **Hysteretic Curves.** Figure 6 shows the force versus rotation relations of reinforced reactive powder concrete specimens tested under reversed cyclic loading. It can be observed from Fig. 6 that two different kinds of hysteretic curves were generated, depending on the type of failure that occurred in the specimen: flexural failure of the beam or shear failure of the joint core.

(1) Specimens EJ-4EA-0 and EJ-4EA-1, which exhibited plastic hinge failure in the beam, have similar hysteretic curves. During the early loading stage, when specimens were in the elastic stage, the hysteretic curve is approximately linear, indicating the absence of residual deformation when unloading. With the increase of the cyclic load at the free end of the beam, the area enclosed by the load-deformation hysteretic curve increases gradually, and the hysteretic loops do not show obvious pinching.

(2) Specimens EJ-4ES-1, EJ-6E-0, and EJ-6E-1 all showed shear failure in the joint core. Load-deformation hysteretic loops resemble a stable bow shape and indicate relatively low residual deformation when unloading, before cracking of reactive powder concrete occurred in the joint core. As the level of displacement and loading increased after cracking, the degradation of stiffness and strength can be observed in the hysteretic curve, as well as residual deformation, which results in less pinching of the hysteretic curve. Compared with other specimens, the curve of EJ-6E-1 showed less pinching, which can be attributed to the inconspicuous plastic hinge formation in the beam adjacent to the joint core. The shear bearing capacity of specimen EJ-6E-1 was higher than those of other specimens due to the configuration of the stirrup in the joint core.

(3) As compared with specimen EJ-4ES-1, specimens EJ-6E-0 and EJ-6E-1 had higher seismic deformation capacity and ductility, and exhibited slower degradation of stiffness and strength.

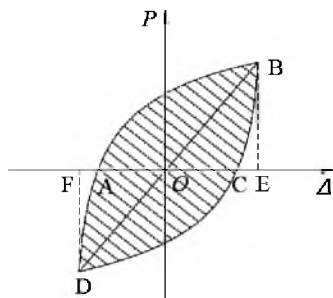
Fig. 7. Calculation for equivalent viscous damping factor.

**2.4. Energy Dissipation Capacity.** Energy dissipation capacity is an important indicator of the seismic performance of structures and components. It can be estimated from the area enclosed by the load-displacement hysteretic loop. The equivalent viscous damping factor  $h_e$  is adapted in this paper to measure the energy dissipation capacity of a reinforced reactive powder concrete frame joint. The calculation method is illustrated in Fig. 7 and the equivalent viscous damping factor is defined as

where  $S_{ABC} + S_{CDA}$  represents the area enclosed by the loop in the load-displacement response, and  $S_{OBE}$  and  $S_{ODF}$  represent the area enclosed by the triangles  $OBE$  and  $ODF$  in Fig. 7.

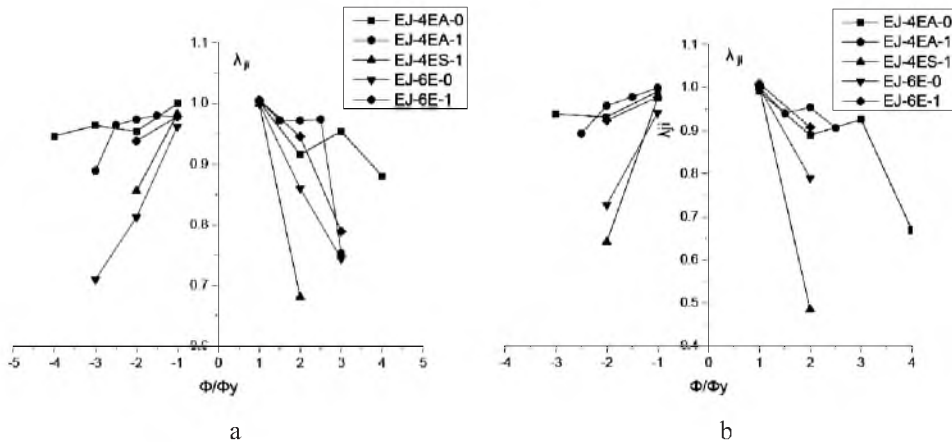
Fig. 8. Strength degradation coefficient of specimens; (a)  $i = 2$ ; (b)  $i = 3$ .

Figure 8 shows the strength degradation versus deformation ( $\Phi/\Phi_y$ ) relationship of reinforced reactive powder concrete joints. It can be observed from Fig. 8 that for all specimens, strength degradation was not obvious at the loading stage of  $\Phi_y$ , but a gradual increase began at  $2\Phi_y$ . The strength degradation of specimens EJ-6E-0 and EJ-6E-1 was far less than that of specimen EJ-4E-1, which could be attributed to the capacity of high-strength steel bars and reactive powder concrete to work well in cooperation. In addition, the stirrups in the joint core provide essential confinement that can retard the development of cracks and degradation of strength in reactive powder concrete. Therefore, the appropriate utilization of stirrups is necessary to achieve the essential confinement of reactive powder concrete.

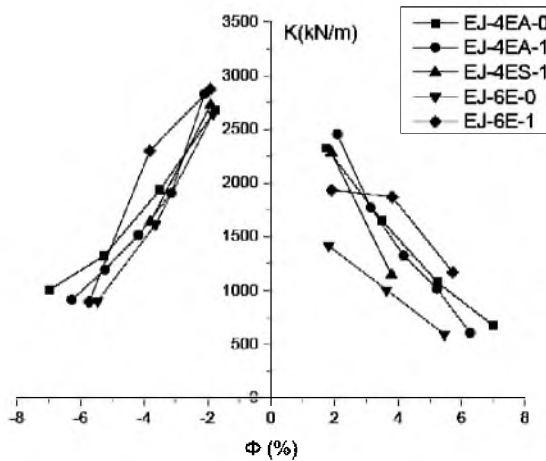
Fig. 9. Stiffness coefficient versus deformation relations of specimens.

Figure 9 shows the stiffness coefficient versus deformation relations of reinforced reactive powder concrete joint specimens. With the increase of deformation of the beam end, secant stiffness of all specimens gradually decreased, following a similar degradation trend. However, the addition of high-strength HRB600E steel bars caused the rate of degradation of stiffness to decrease compared with HRB400E bars. The use of stirrups in the joint core significantly increased the initial secant stiffness values of the specimens and provided a stable rate of reduction in secant stiffness up to failure.

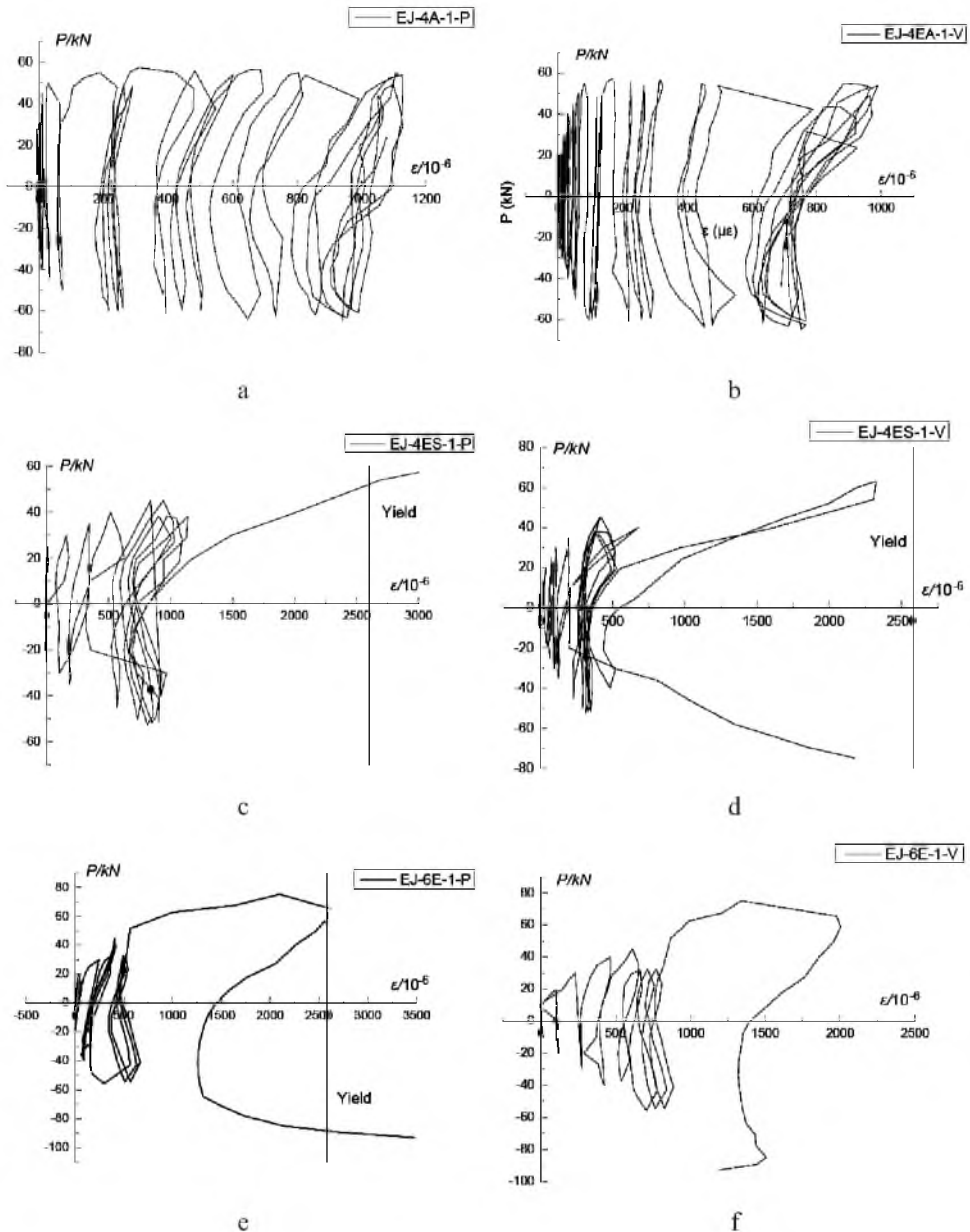
Fig. 10. Strain of stirrups in joints.

**2.7. Strain of Stirrup in Joint Core.** Figure 11 shows the stirrup strain versus deformation relations of specimens EJ-4EA-1, EJ-4ES-1 and EJ-6E-1. The strains of stirrups in the joint core parallel and perpendicular to the beam length direction are represented by “-P” and “-V”, respectively. Before cracking of reactive powder concrete occurred in the joint core, stirrup strains were smaller, usually less than  $500 \cdot 10^{-6}$ , and unloading could restore the stirrups to their original locations. Stirrup strains in the parallel direction showed a rapid increase and residual deformation after cracking. At the same time, stirrup strains in the perpendicular, or vertical direction developed relatively slowly.

Specimen EJ-4EA-1 acquired only a few small diagonal cracks in the joint core prior to complete failure, and the stirrup in the joint core remained in an elastic stage (Fig. 10a), the maximum strain of which was  $1127 \cdot 10^{-6}$ .

Stirrup strains in the parallel direction of specimen EJ-4ES-1 quickly increased and exceeded  $3000 \cdot 10^{-6}$  in the first cycle of  $2\Phi_y$ , which represents the tensile yield of stirrups

in that direction, while stirrup strains in the vertical direction were  $2317 \cdot 10^{-6}$ . With the increase of loading deformation, these strains continued to increase until yield.

When the specimen was subjected to downward (positive) deformation in the first cycle of  $2\Phi_y$ , stirrup strains in the parallel direction and vertical direction of specimen EJ-6E-1 were approximately  $2098 \cdot 10^{-6}$  and  $1341 \cdot 10^{-6}$ , respectively. Upward (negative) load near the peak caused yield strain in the stirrups in the parallel direction; at this point, stirrup strains in the other direction were  $1200 \cdot 10^{-6}$ . Stirrup strains in the vertical direction eventually exceeded yield strain at ultimate failure. The experimental results demonstrate that stirrups in the joint core directly bear part of the shear forces while providing essential
