Fatigue Fracture Analysis of Composite Plates with an Elliptical Hole

In this study, the analysis of fatigue fracture of composite plates with an elliptical hole having a longer axis parallel to the direction of the applied force is performed. The plates were made of glass/epoxy preimpregnate consisting of eight individual layers with the fiber configuration of $[+45^{\circ}/-45^{\circ}/+45^{\circ}/-45^{\circ}]_S$. The mechanical properties and material constants were assessed by performing static tensile tests and analytical calculations. The nominal fiber volume in the composite plates was experimentally determined. The test method of infrared passive thermography was implemented as a non-destructive testing, which provided the determination of the temperature distribution throughout the entire fatigue process. The thermograms were obtained and compared to the real-time photographs of the plates. Moreover, the specific results concerning fatigue phenomena and basic composite failure forms, which usually occur during the fatigue process, are discussed in detail. The theoretically predicted three individual fatigue fracture phases were corroborated the original test results. The f

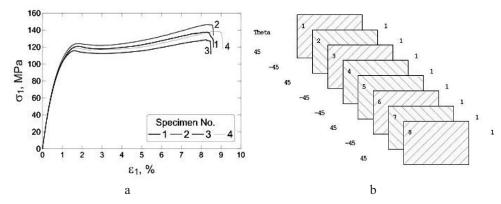
Fig. 2. Stress-strain plots for the $\pm 45^{\circ}$ fiber configuration laminate (a) and configuration of the individual layers in the laminate (b).

The curves presented in Fig. 2a show the stress–strain relationships during the tensile test of the 0° fiber orientation plate. The curves are very similar for all four specimens. The stresses increased rapidly at the first process stage, while the strains increased very slowly according to the damage evolution pattern. After reaching about 85% of the ultimate tensile strength, the curve becomes almost flat, the force stabilizes, and the strain increase can be observed. For conventional ductile materials, this phase is called a plastic flow. At this

The static tensile and fatigue tests were conducted for the glass/epoxy preimpregnate composite plates with a central elliptical hole. The symmetrical configurations $[+45^{\circ}/-45^{\circ}/+45^{\circ}/-45^{\circ}]_{S}$ of the layers are depicted in Fig. 2b. Each finished plate had additional holes drilled, and the cover plates were glued, in order to protect the structure from damage. The plate was mounted in the brackets with ten M10 bolts tightened with a torque of 36 N·m to obtain a uniform load distribution.

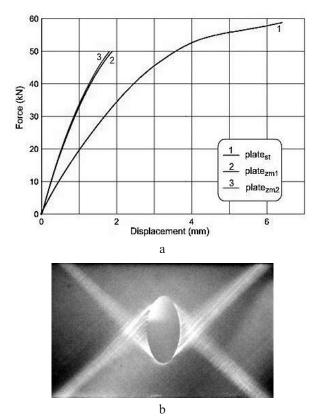
Fig. 4. Force—displacement curves for three tested composite plates: one subjected to static loading and two subjected to a cyclic one (a) and a side view on the damaged plate (b).

A Static Tensile Strength of the Composite Plate with an Elliptical Hole. The average load value, which was realized in the cyclic tests, was determined for comparing the static and fatigue fracture forms. Figure 4 presents the force—displacement curve for two plates subjected to the average cyclic load, and also for the statically tested plate. Initially, the plate_{st} should have been damaged during the tensile test. This was impossible due to the improperly designed brackets, which became deformed during the test. Therefore, this plate's deformation is extremely high because it is the sum of the plate's elongation and the

brackets' deformation. The static tensile loading was conducted with a forced displacement of 0.5 mm/min. The loading process of the plate_{zm1} and plate_{zm2} ran properly because the brackets were properly set (additional pressure plates were added). During these tests, the tensile force increased in time, and it was 9 kN/min. The curves for plate_{zm1} and plate_{zm2} were obtained by loading the plates to the average value of the cyclic load.

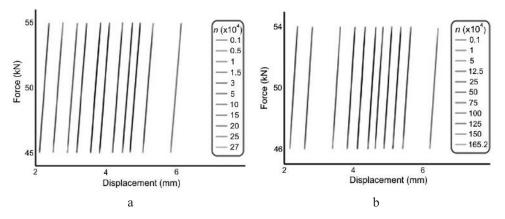
Fig. 5. Exemplary hysteresis loops for plate_{zm1} (a) and plate_{zm2} (b).

Figure 5 presents the examples of hysteresis loops for the plate_{zm1} and plate_{zm2} obtained during the fatigue tests, which were used to determine the stiffness degradation of the tested laminates.

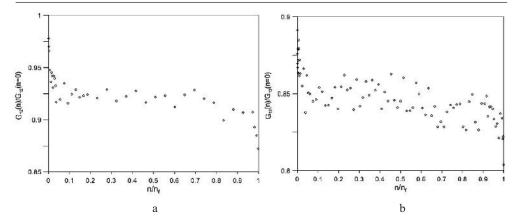
Fig. 6. Laminate stiffness degradation accordingly for the plate_{zm1} (a) and plate_{zm2} (b).

The characteristic curves of the stiffness degradation for the plate_{zm1} and plate_{zm2} are depicted in Fig. 6. The horizontal axis is the ratio of realized n cycles to the number of cycles, which caused the laminate damage, N_f . The vertical axis presents the ratio of stiffness modulus to the static stiffness modulus determined for n = 0.

The experimental results are compatible to the theorerical ones, whereas the reduction of plate stiffness is observed throughout the entire fatigue process. A sudden stiffness degradation at the first fatigue stage, followed by a further stabilization, can be observed for both plate_{zm1} and plate_{zm2}. After reaching 50,000 cycles for the plate_{zm1}, strains slowly decrease, and the curve runs linearly until the number of 200,000 cycles is reached. Then, a sudden laminate stiffness degradation occurs, and the strains increase (Fig. 7). The curve obtained for the plate_{zm2} has a similar pattern. Despite the large difference in the number of cycles between the two plates, their deformation patterns are similar. At the first process phase (phase I), the laminate deformations increase, and the number of cycles is low. Then, the curve stabilizes, and the deformations increase gradually (phase II). At the final phase (phase III), a sudden deformation increase can be observed, which results in a total laminate destruction.

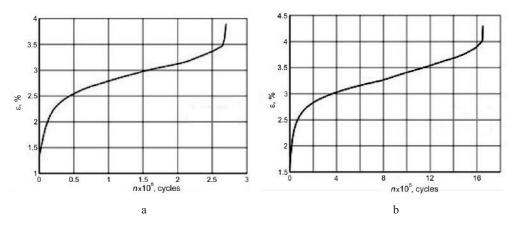
Fig. 7. Deformations increase dependent on the cycles number for plate_{zm1} (a) and plate_{zm2} (b).

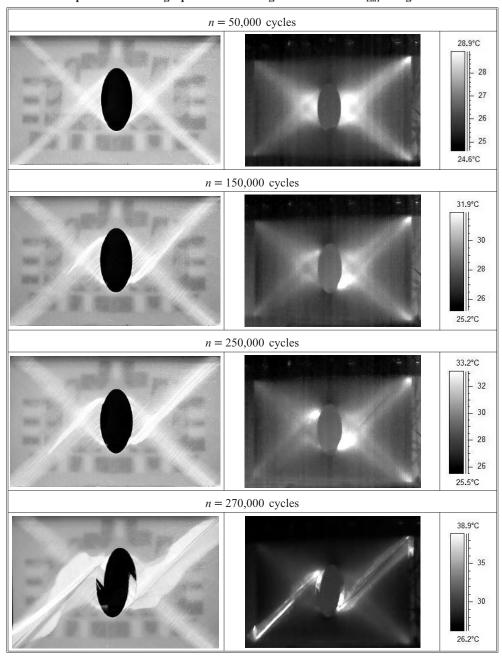
T a b l e 6

A Comparison of Photographs and Thermograms of the Plate_{zm1} Fatigue Process

Non-Destructive Testing of an Infrared Passive Thermography. In order to obtain as much information as possible, the plates were photographed throughout the entire fatigue process, and the infrared passive thermography method was implemented. A thermovision camera FLIR A324 and the ThermaCAMResearcher Pro software was used in the experiment [12]. A phenomenon of thermal energy dissipation into the atmosphere is caused by an initiation and propagation of the laminate damage. Due to recording of the local temperature increase via an IR camera, further fatigue fracture analysis was possible. Tables 6 and 7 present a comparison of photographs and thermographs for plate_{zm1} and plate_{zm2} for particular cycle numbers. The failure initiation is very similar for both plates.

At the early stages of the failure, surroundings of the hole are damaged first due to the local stress concentrations area. Then, the failure propagates in the corner direction. Light color along the diagonals responses for the matrix cracking in the initial damage phase. This phenomenon can be observed in the photographs presenting appropriately 50,000 cycle number for plate_{zm1} and 100,000 cycle number for plate_{zm2}. Early matrix–fiber separations and local delaminations in hole's neighbourhood can be observed for plate_{zm1} at the 50,000 cycle number already. This phenomenon occurs for plate_{zm2} at the cycle number of 100,000. Cycle amount of appropriately 150,000 for plate_{zm1} and 600,000 for plate_{zm2} led to significant and visible damage of the laminates, where the failure caused by matrix–fiber

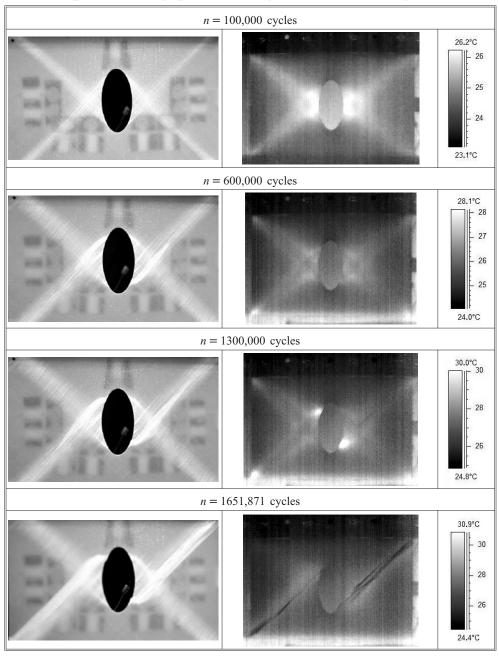
T a b 1 e 7

A Comparison of Photographs and Thermograms of the Plate_{zm2} Fatigue Process

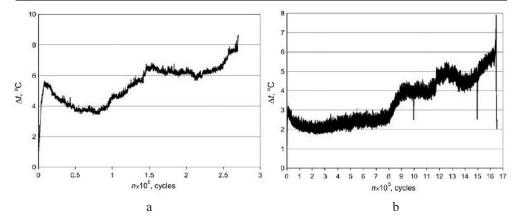
Fig. 8. Curves presenting the differences between minimum and maximum temperatures around the elliptical hole appropriately for plate_{zm1} (a) and plate_{zm2} (b).

The graphs below present the differences between minimum and maximum temperature recorded around the elliptical holes (Fig. 8). Increase and decrease of the temperatures depended on the failure forms which occurred at the particular time of the fatigue process.

At the large amount of matrix—fiber separations, the temperature around the holes decreased gradually. With the growth of the cycle number, the plate temperature increased, and the temperature difference increased as well, which can be observed below. In the early process phase, a sudden rise of the temperature gradient can be observed. Then, the gradient decreases, and finally the temperature difference increases with the gradual increase of the cycle number. The plates were not being destroyed perfectly symmetrically, which could affected the non-uniform character of the discussed curves. With less

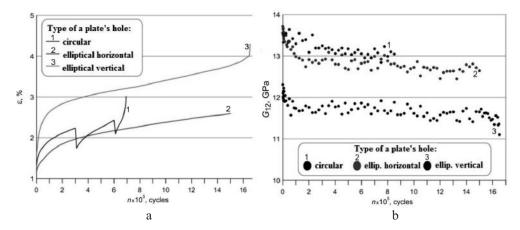
Fig. 9. Deformations increase dependent on the cycles number for three plates with various hole type (a); a comparison of laminate stiffness degradation for three various hole types (b).

The graph above presents the dependence of deformations increase and cycle number curves for the three plates with various holes (Fig. 9a). The curve which differs extremely from the others concerns the plate having a circular hole. This difference caused by the fact that this experiment was divided into three days, due to the restrictions of the machine working time (the work parameters were the same). In the initial fatigue phase, a sudden strains increase appears at low cycles number and is observed for all the plates (phase I). Next, the curve run stabilizes and the deformations increase very slowly (phase II), and in the final stage it leads to the overall damage of the laminate (phase III). However, this curve does not reflect the correct nature of the curve due to the experiment's division on over three days, which resulted in staggering of the laminate deformations. The plate having an elliptical (horizontal) hole was not totally damaged, which was caused by a limited working time of the strength machine (the experiment lasted from morning till night). The cycles number of 1500,000 was not enough to destroy the laminate. The curve for the plate having an elliptical (vertical) is almost the same as for the previously described plate. Three failure phases which are typical for composite materials can be distinguished. However, the curve of the plate having a vertical elliptical hole is more stabilized and the failure phases are easier to observe and distinguish.

Figure 9b presents the stiffness degradation chart for the plates having three various holes. The curves are greatly similar to one another. In the initial process phase, a sudden stiffness degradation can be observed for the plates having elliptical holes. The plate having a circular hole has a stabilized and smooth curve in the initial process stages. This curve shows a slow and gradual degradation of the laminate stiffness throughout the whole fatigue fracture process. The curves for elliptical holes stabilize after exceeding the first phase of the sudden stiffness decrease, and the degradation proceeds slowly and gradually.

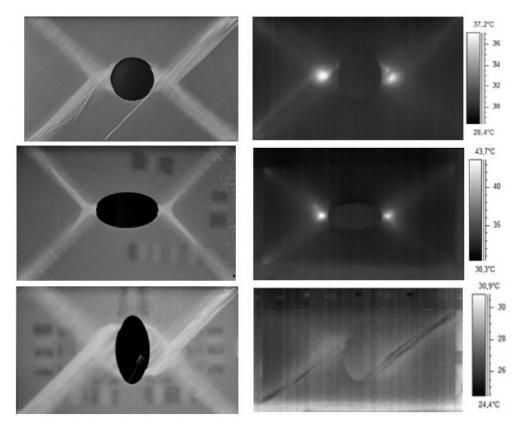
Fig. 10. A comparison of the plates having various hole just before the destruction moment.

The plate having a horizontal hole has the lowest average load value, which could affected its relatively low damage compared to the other plates (Fig. 10). All the plates had the same force amplitude of 4 kN. The plate with a circular hole varied from the other

plates by a frequency value which equaled 15 Hz, and for the elliptical holes 30 Hz. The failure forms of all plate types were compared to their appropriate thermograms. The plate having a circular hole was destroyed after 692,565 cycles, the plate having a horizontal elliptical hole after 1500,000 cycles, and the plate having a vertical elliptical hole after 1651,871 cycles. The fatigue damage process was similar for all composites. Initially, some local fiber—matrix separations could be observed, and also local delaminations. Further, the damage propagated to the plate corners and large areas of fiber—matrix separations were visible (especially for the plates with circular and vertical holes), which finally led to the destruction of the whole laminate.
