EFFECT OF EXPOSURE INSIDE THE LHD VESSEL ON REFLECTANCE OF STAINLESS STEEL MIRRORS

*V.S.Voitsenya, A.Sagara¹, A.F.Bardamid², A.I.Belyaeva³, V.N.Bondarenko, A.D.Kudlenko³,
V.G.Konovalov, and S.I.Solodovchenko*

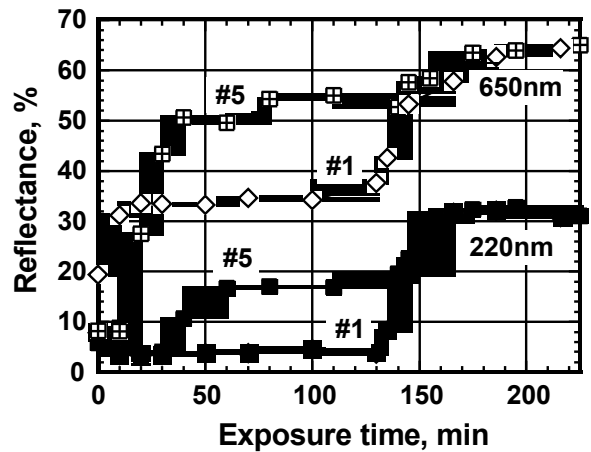
Fig.3. The recovery of reflectance (normal incidence, wavelengths 220 nm and 650 nm) of samples #1 and #5 due to deuterium ion bombardment. Up to $t=130$ min for sample #1 and up to $t=140$ min for sample #5 the sample holder was grounded, i.e., the energy of ions was <15 eV.

After that times the samples were exposed to ions accelerated to ~ 300 eV because of negatively biased holder.

The time dependences of reflectance recovering at two wavelengths for both samples are shown in Fig.3. These data demonstrate that the characteristics of films that appeared on these samples are very different. Namely, the film on the #5 sample was thicker (because the interference effects are seen) but softer than the film on the #1 sample. The rate of reflectance recovering by the #5 sample during the cleaning regime (i) was much faster in comparison to the #1 sample, however for both samples the recovering was stopped after about one hour cleaning time. For the #5 sample this "saturation" of mirror recovering (in the time interval 60-140 min) is probably due to full disappearance of the carbon film deposited inside the LHD vessel, and the remained film was the one connected with washing the sample in an ultrasound bath after the finish of polishing. This lowest contaminating layer was gradually disappearing, starting from the time 140 min. For the #1 sample the intermediate saturation level behaved in the way like the rest film consisted of not one but two layers: the upper which disappeared by ion bombardment during 130-145 min was probably the rest of the layer deposited in LHD, and the lower one which had the thickness and composition similar to the layer that maintained on the #5 sample due to washing in an ultrasound bath. The full

The data obtained at this stage of experiment demonstrate that the location of the mirror samples inside the LHD vacuum chamber is very important factor determining the rate of mirror degradation. The mirror #3 located close to the plasma confinement volume and quite distant from the divertor regions was cleaned from the contaminating film that appeared as a result of rinsing samples in the ultrasound acetone bath and profilometry and SEM data show that it saved the very smooth surface. Mirror #1, fixed close to the divertor region with graphite tiles as the divertor plates, became coated by the film of complicated composition. The thickness of deposited films found by AES and ellipsometry are not in agreement each other. Namely, according to AES the thickness was estimated as ~ 70 nm for #1 and ~ 700 nm for #5 but only ~ 26 nm from ellipsometry data for #1 sample. The carbon film thickness on the mirror #5, fixed deeply in the port, was much thicker according to optical measurement (Fig.2) and results of cleaning (Fig.3) however it could not be measured by ellipsometry, as was mentioned above.

The resistance of deposited films to impact of low energy D ions is quite different as data of Fig.3 show. The cleaning process demonstrates that the film on the #1 sample was significantly harder than that on the sample #5. This is probably the result of high percentage of iron in the composition of the deposit. The SEM photos demonstrated that the film on the #5 sample was strongly inhomogeneous compare to the quite homogeneous film surface on the #1 sample.
